# Tim Spargo - Certified Inspector

## SUMMARY REPORT

**Client:** Name Omitted - Sample  
**Inspection Address:** 123 Main Street, Palmdale, CA 93551  
**Inspection Date:** 10/5/2010  
**Inspected by:** Tim Spargo

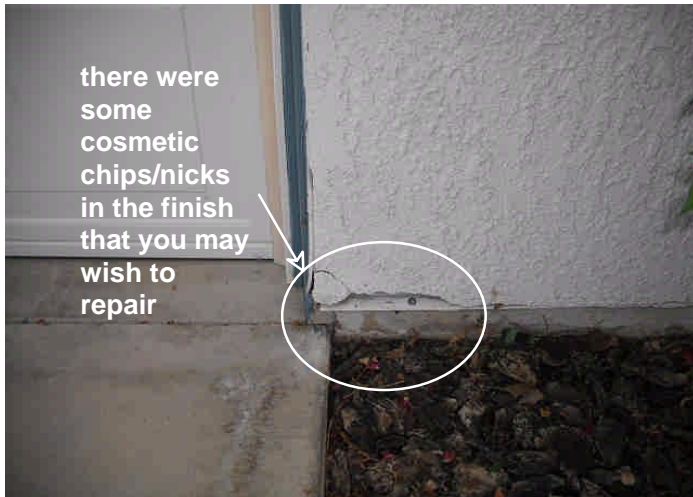
1.4 - Overall Wall finish is in acceptable condition. Cracks may appear over time around doors and windows as most structures move and settle, which is not uncommon. If cracks develop over 1/8", they should be repaired or sealed. Sprinklers should be directed away from the home and chips and cracks may need to be repaired as they appear, which is part of maintaining your home.

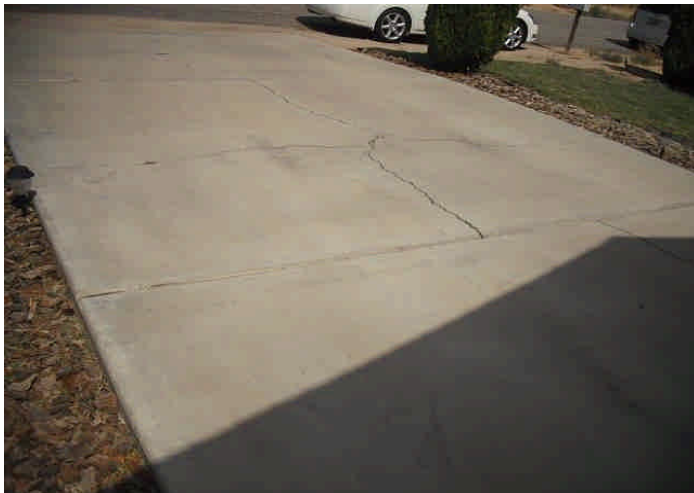
1.6 - The concrete driveway is in acceptable condition. Small cracks or stains are cosmetic in nature and are not a significant concern at the time of inspection.

1.7 - There are predictable cracks in the driveway that would not necessarily need to be serviced.

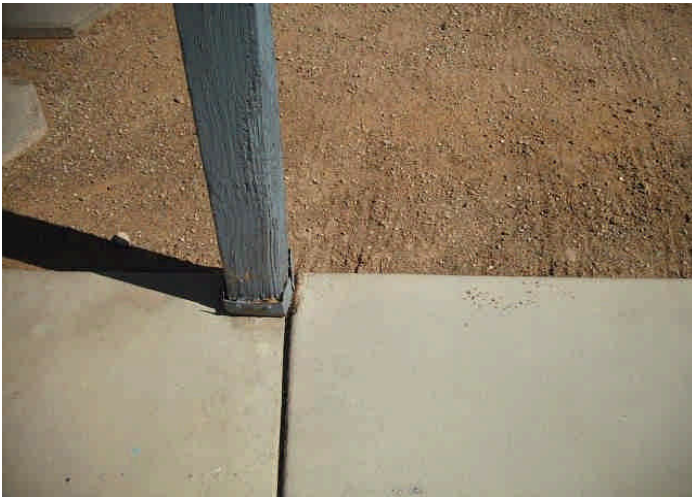
1.13 - Right hand or outer post base is loose to concrete - secure this item to prevent movement

- Right hand or outer post base is loose to concrete - secure this item to prevent movement

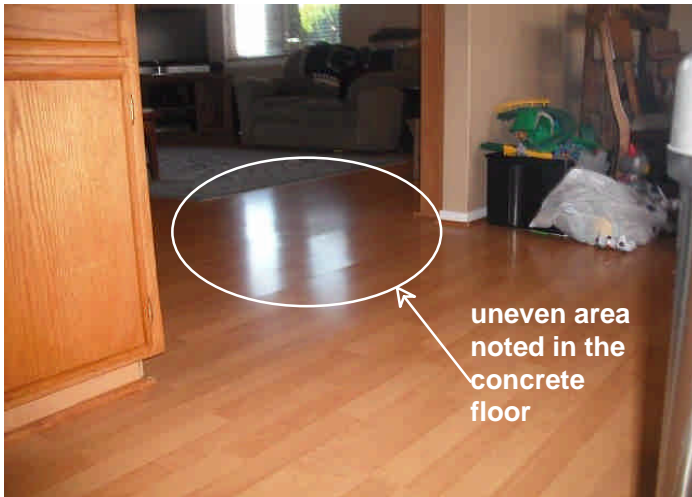
2.8 - The residence has a bolted, slab foundation with no visible or significant abnormalities.  
2.9 - There is an uneven area in the floor near the kitchen and hall area, this area is slightly raised or crowned. This area of the floor is presumed to be non-bearing or non-structural in connection to the structure, but nonetheless the area would take significant work/repair to level this area if you chose to do so.

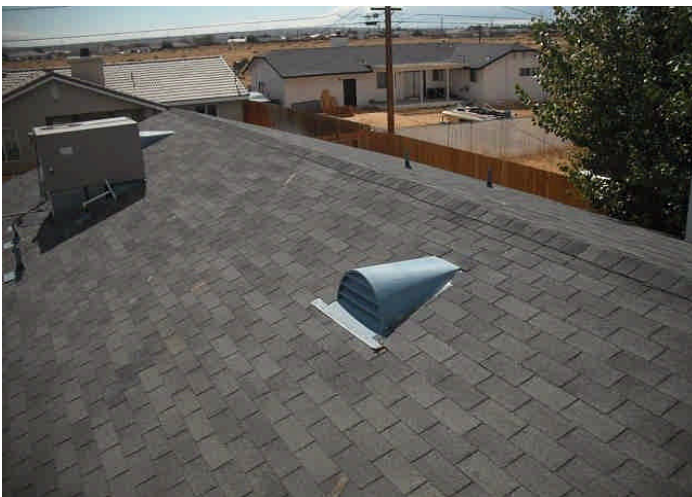
3.2 - We evaluated the roof and its components by walking on its surface.

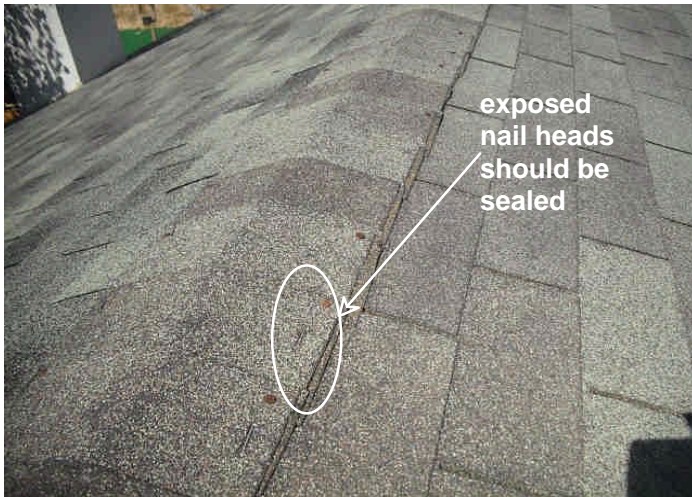
3.4 - The south half of the roof is in the primary stages of decomposition, which means that the roof is in decline and susceptible to leaks. It will need to be maintained and closely monitored, because it is reaching the end of its serviceable life, and you may wish to have a second opinion before the close of escrow.

3.5 - As a recommendation client should seal exposed nail and staple heads to prevent future moisture intrusion. As the nails and staples that are exposed shrink, they can be an active source of moisture intrusion and should be sealed with an appropriate roof sealant commonly sold at home improvement and hardware stores.

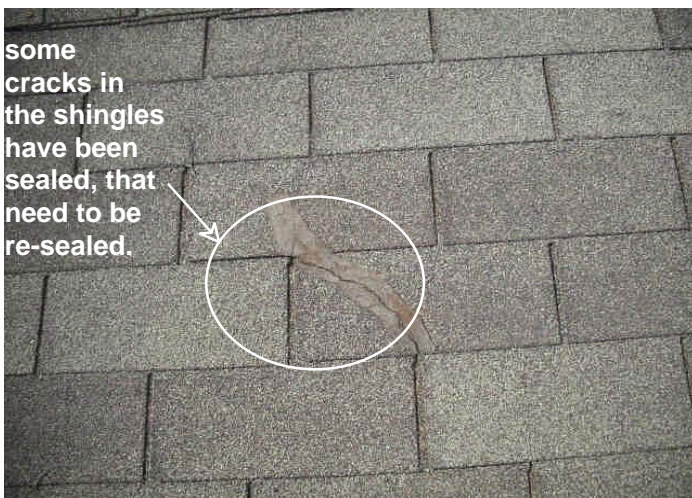
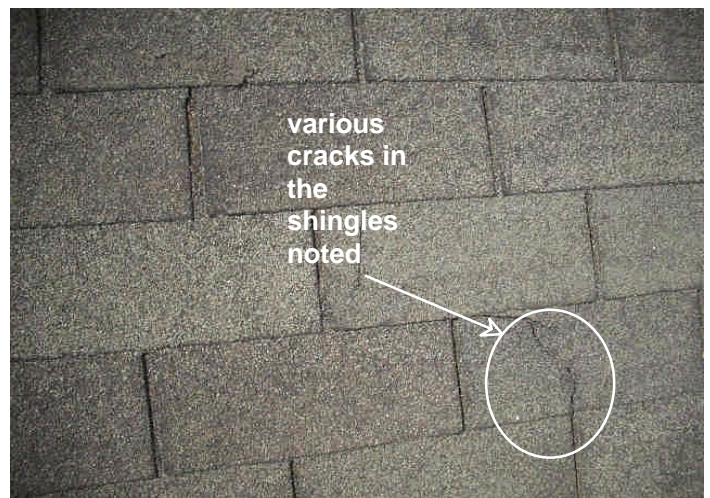
3.6 - Half of the roof is in it's last third of it's service life and should be closely monitored. One half of the roof has be covered or commonly known as a "roof-over", the other half of the roof has not. There are cracks and similar defects in the roof that you may wish to have repaired. At minimum, you should be aware of the anticipated service life as well as the needed repairs on the roof.

- Half of the roof is in it's last third of it's service life and should be closely monitored. One half of the roof has been covered or commonly known as a "roof-over", the other half of the roof has not. There are cracks and similar defects in the roof that you may wish to have repaired. At minimum, you should be aware of the anticipated service life as well as the needed repairs on the roof.

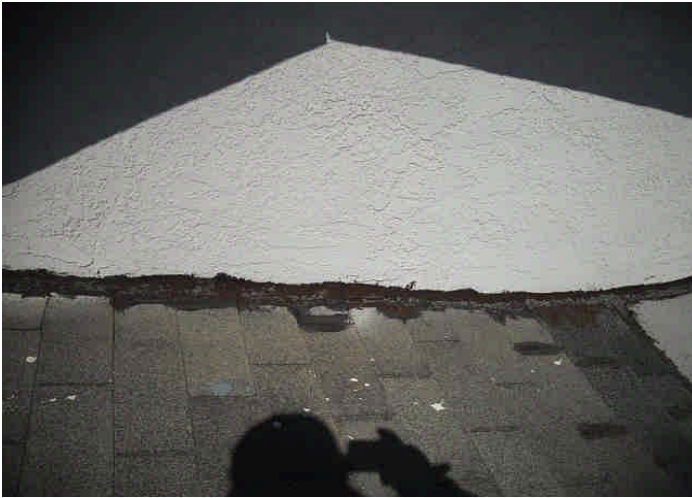
3.8 - There is no visible roof flashing where the roof meets the house. This a general standard to keep water run off from roof from entering the home. Some of these areas have been sealed with mastic, this may be functional, but will require these areas to be inspected every few years.

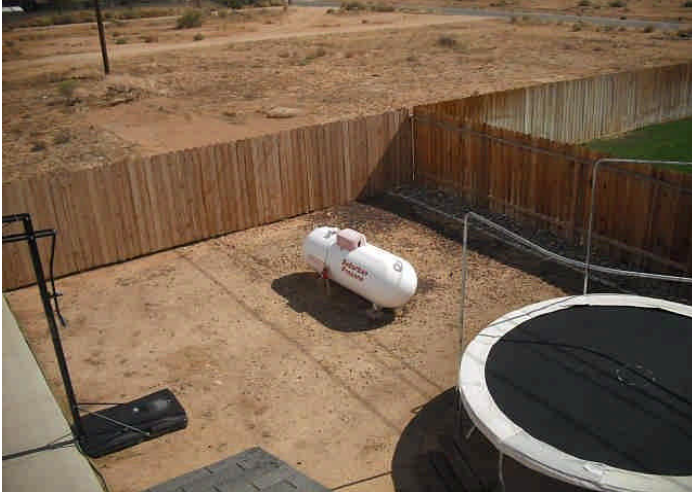
5.5 - Propane tank is located at the back of the property

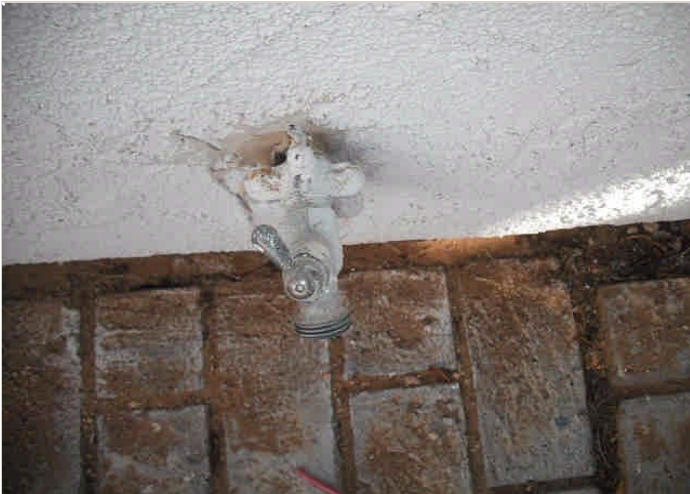
5.18 - Hose bibb handle damaged on the side yard of the home, client may wish to repair.

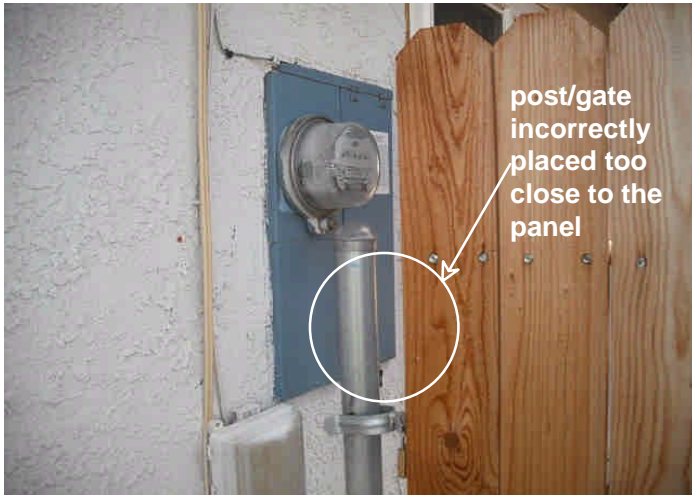
in the common working area for an electrical panel, defined as 30" to the sides and 36" in front of the panel.

The post was placed in an incorrect area. It is possible that the Utility provider may object to it's location as well.

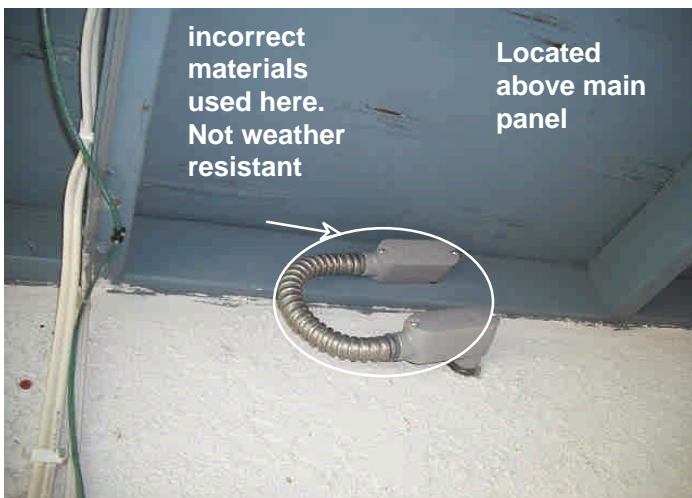
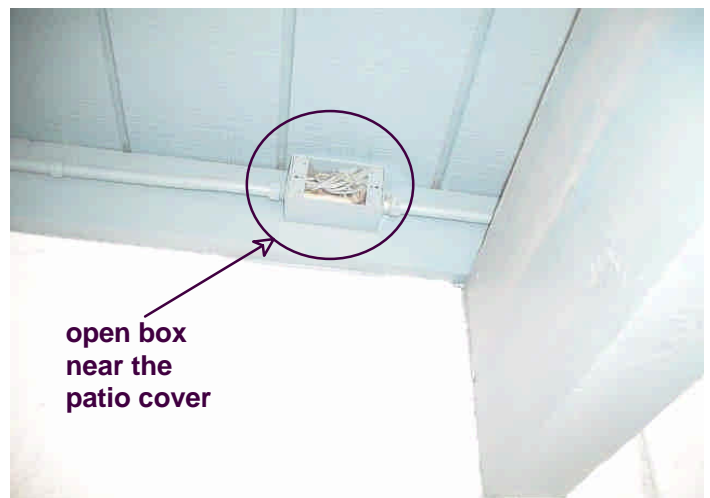
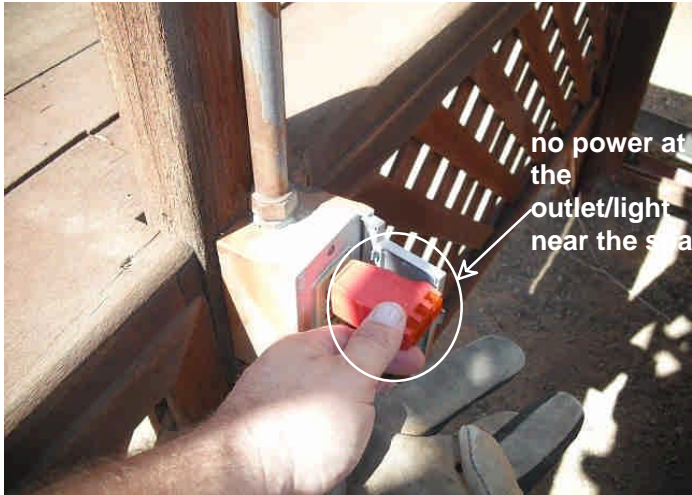
There is a circuit that extends in to the back yard thru the attic that requires service - *Continued*

6.4 - There is a circuit that extends in to the back yard thru the attic that requires service.

The circuit was found to be in the tripped position at the main panel and the circuit had no power at the spa structure when tested.

\* I recommend for reasons of safety to have this circuit evaluated for repair by an electrician.

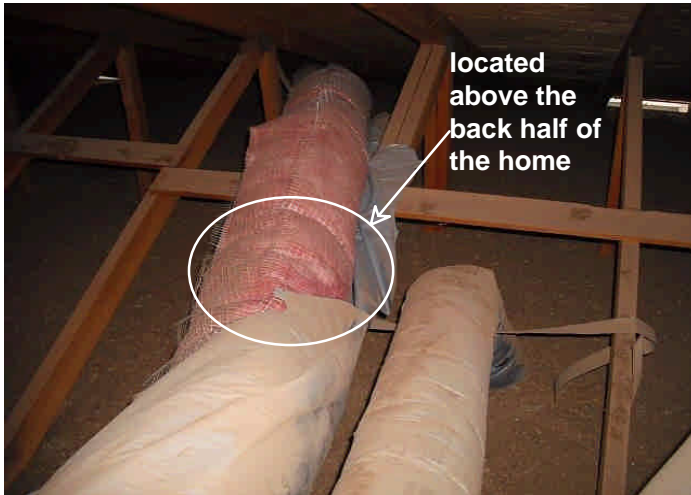
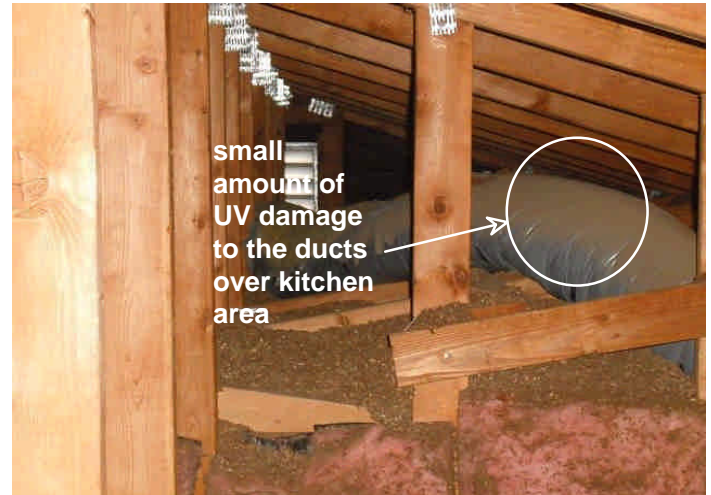
7.15 - The ducts are a modern flexible type that are comprised of an outer plastic sleeve and a clear inner liner that contains fiberglass insulation. However, portions of the outer sleeve are u-v contaminated and should be replaced.

- The ducts are a modern flexible type that are comprised of an outer plastic sleeve and a clear inner liner that contains fiberglass insulation. However, portions of the outer sleeve are u-v contaminated and should be replaced.

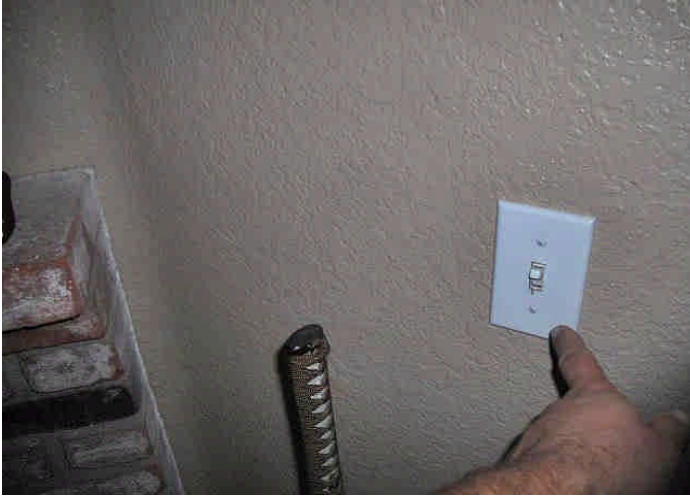
8.17 - Switch with unknown function in the family room - ask seller as to its function

Switch with unknown function in the family room - ask seller as to its function - *Continued*

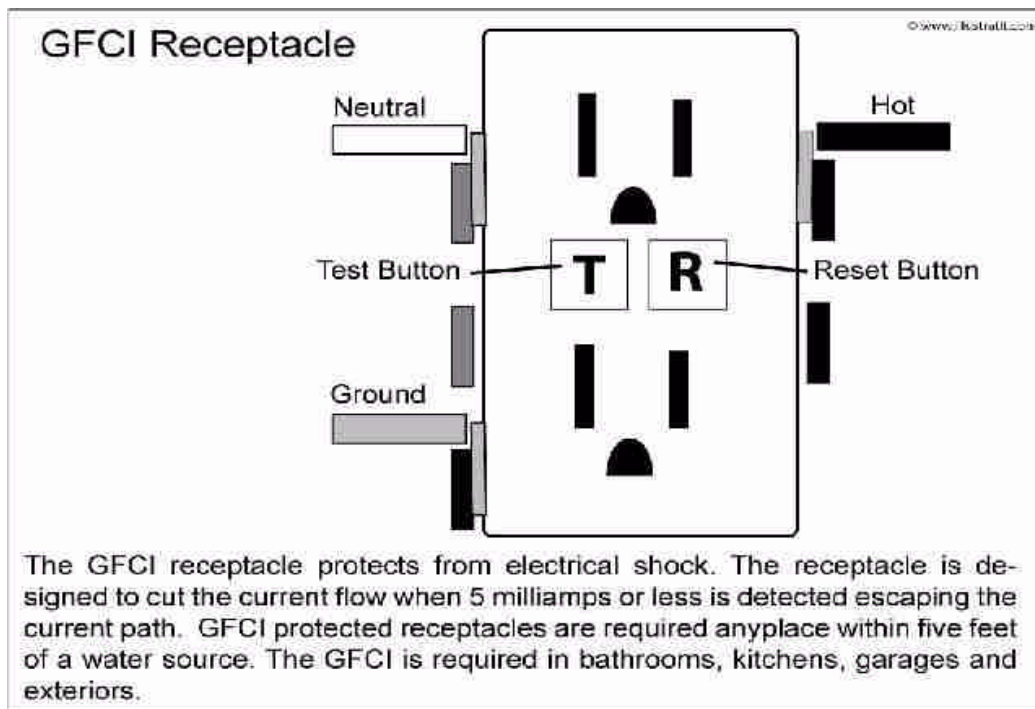
Illustration - 5 The outlets that were tested are functional and include ground-fault protection
